# Jordan Transformer Project Examples

## Remanufacture with Complete Core Steel Replacement

20 MVA FOA @ 75° 115 – 24.94Y x 13.2Y x 4.16Y/2.4 Westinghouse Mobile

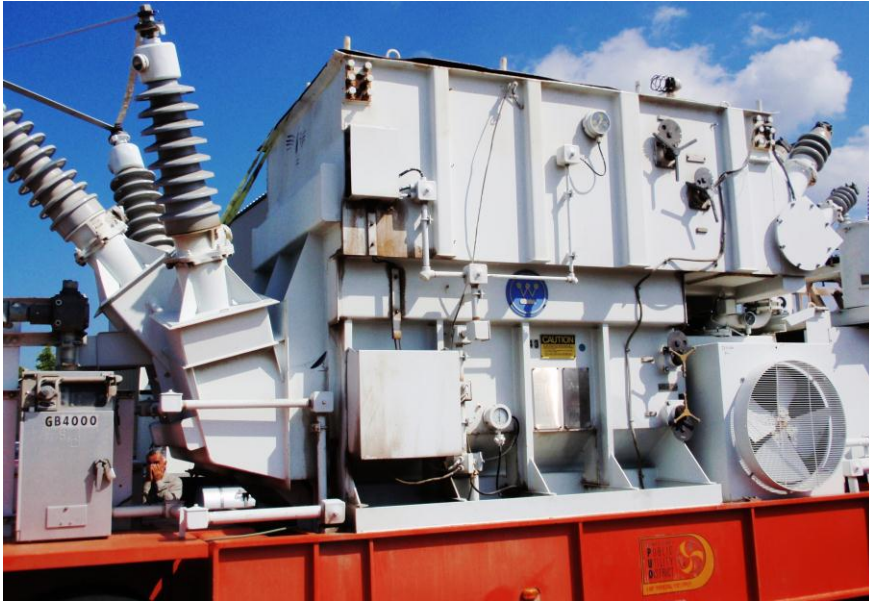
**Damage to Lid from Failure Allowing  
Exposure to Water**

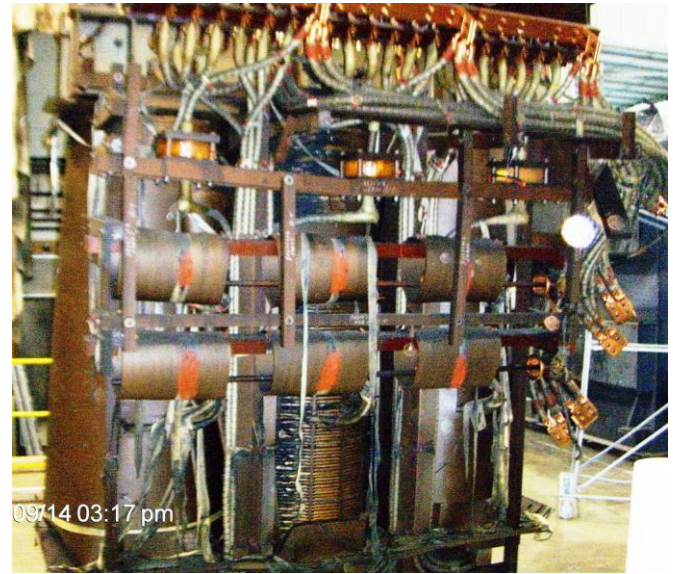
**Core and Coil Assembly with  
Broken Lead Structure**

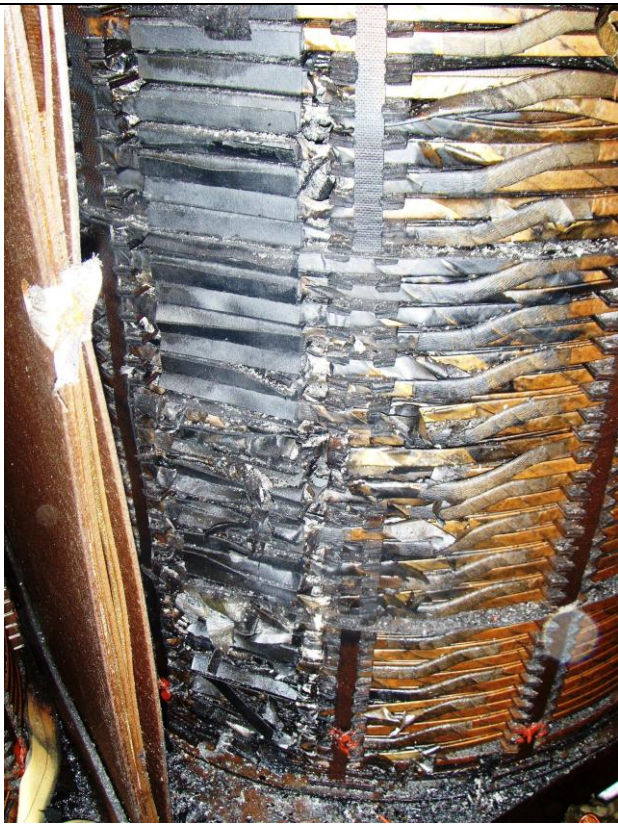
**Failed Primary Aluminum Winding**

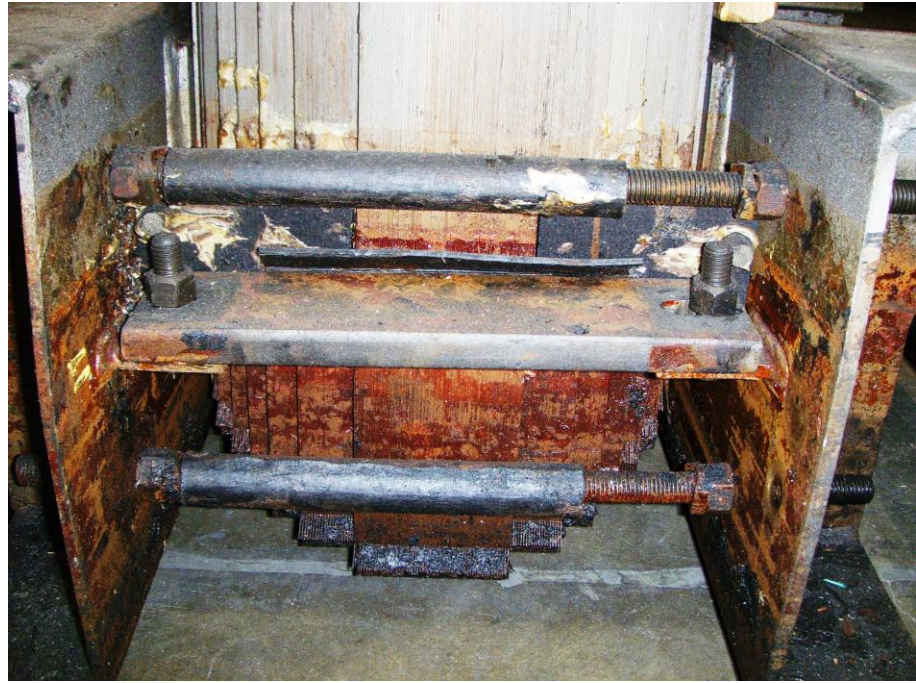
**Rusted Bottom of Core Steel and Bottom Frame from Water Damage**
