Reinhausen LTC Retrofit and Addition of Oil Ducts to Core 24/32/40 MVA 140 – 13.8Y Moloney with LTC

Reinhausen LTC Retrofit and Addition of Oil Ducts to Core

24/32/40 MVA 140 – 13.8Y with Reinhausen RMV-II LTC

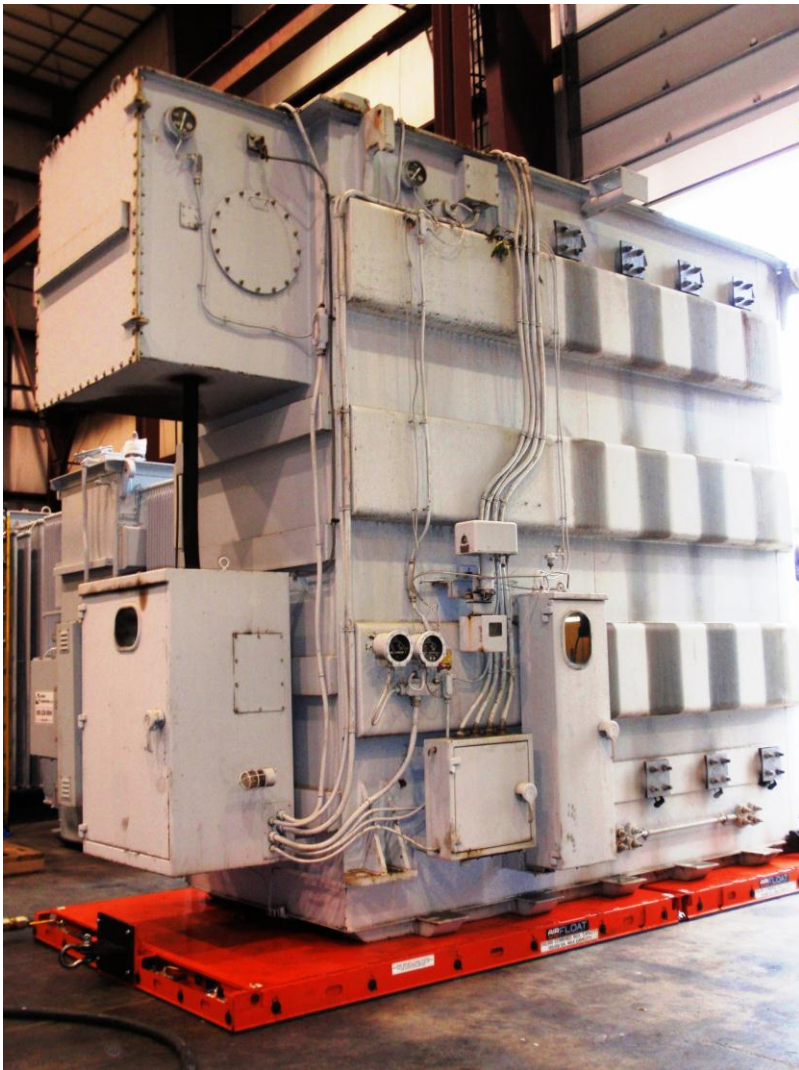
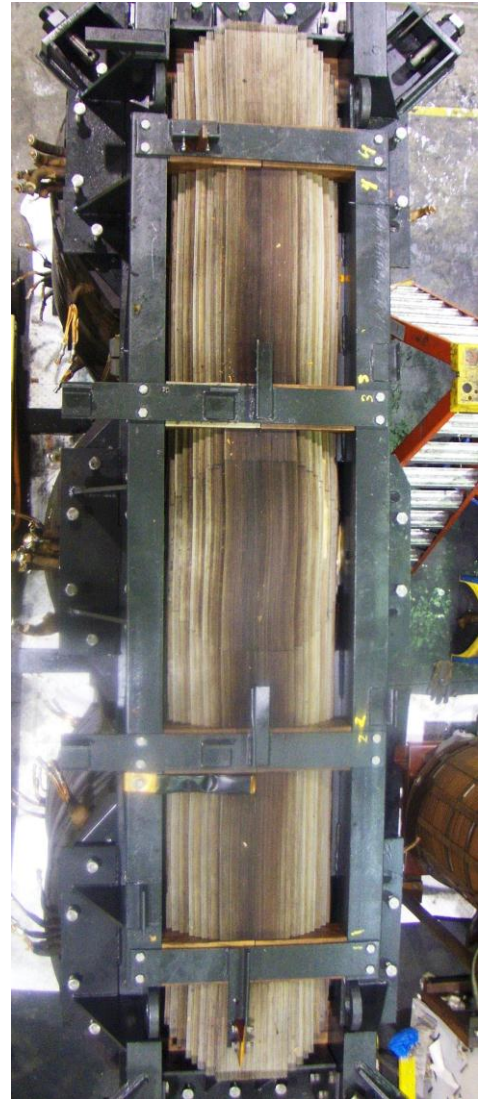
Overhead view of top yolk of core

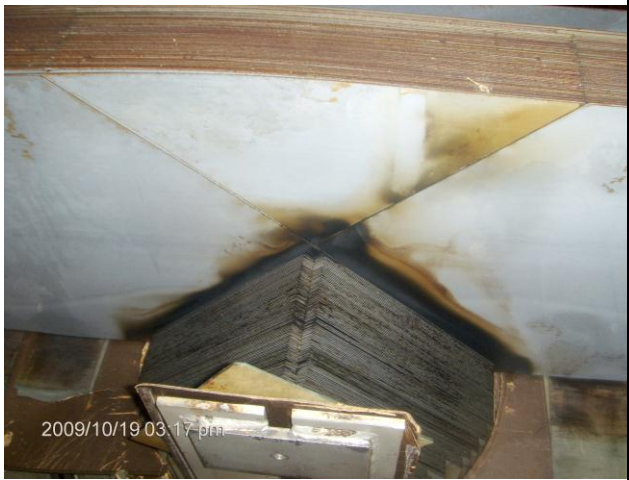
Overheated Sheets of Center Leg Top Yolk

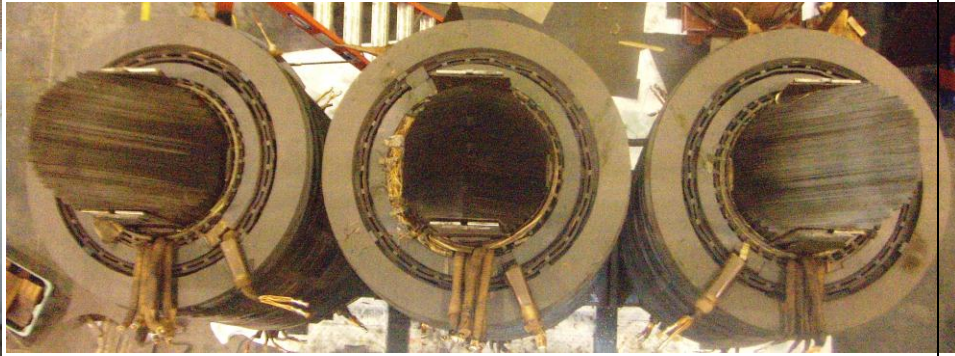
Signs of core overheating after yolk removal

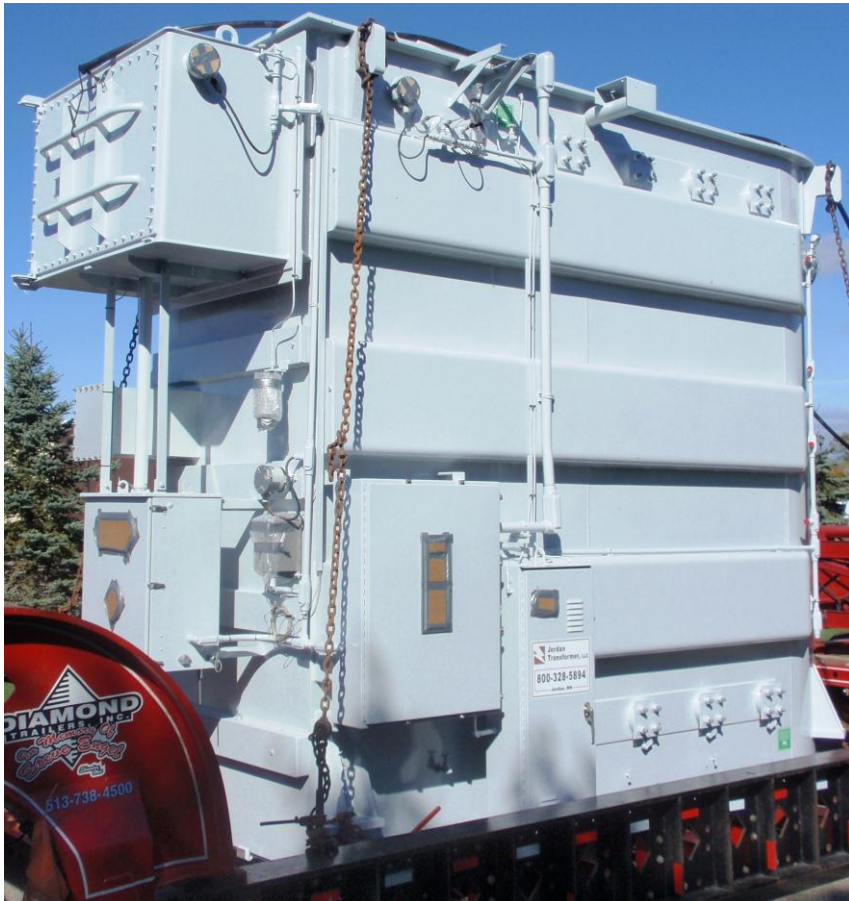
New Reinhausen RMV-II Load Tap Changer

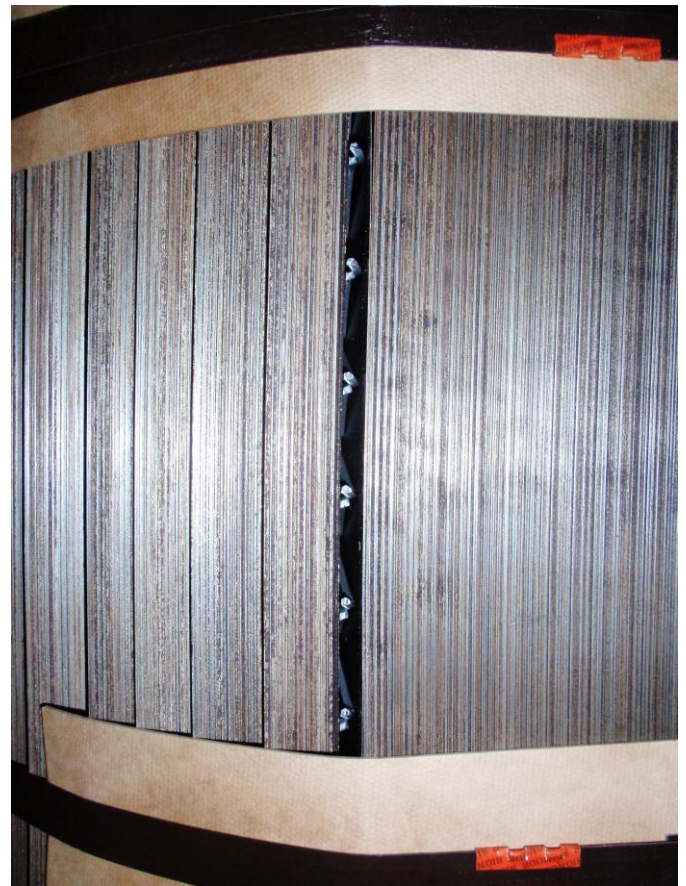
Installation of 1/4" Oil Ducts

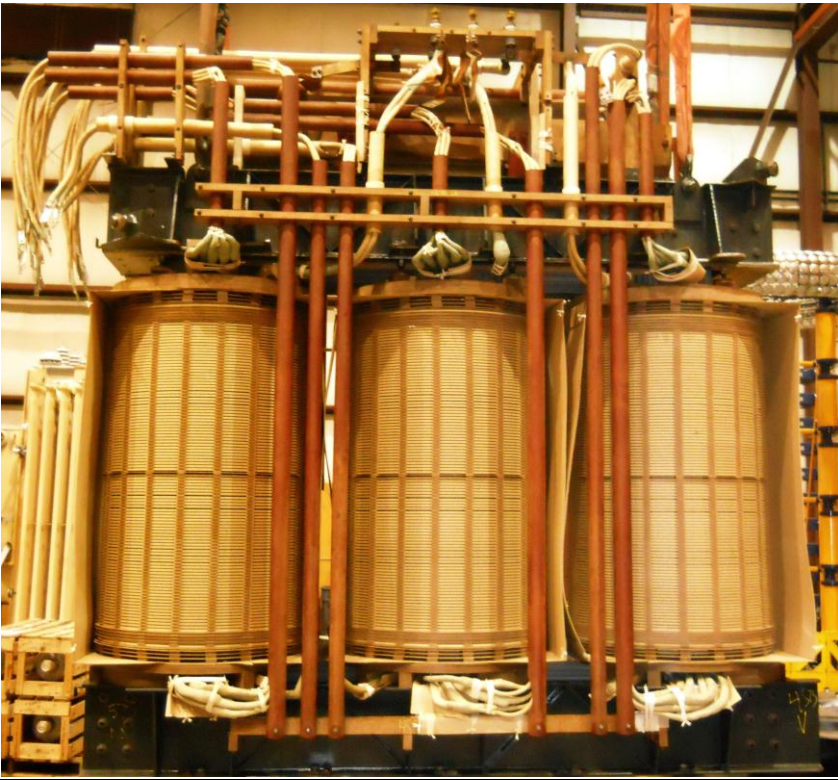
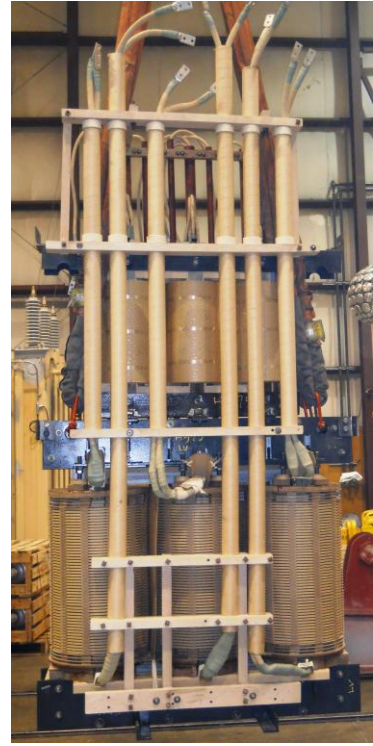
New Series and PA Windings
