# Jordan Transformer Project Examples

## Fire Damage-(Before)

24/32/40 MVA 138 – 13.8Y ASEA with LTC

Fire Damage Repair & Reconditioning – (After) No Rewinding Needed

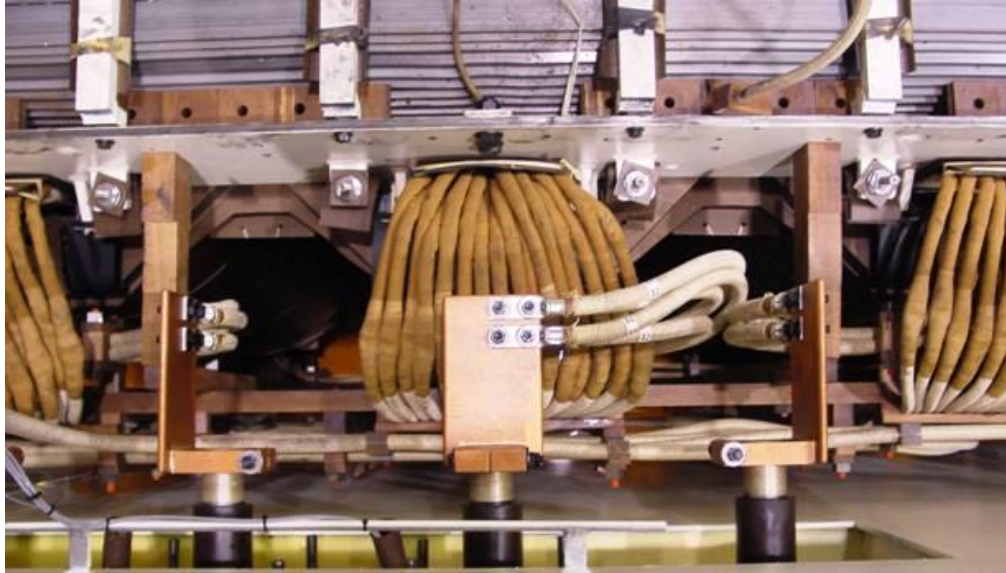
**Overhead view of core & coil assembly before untanking**

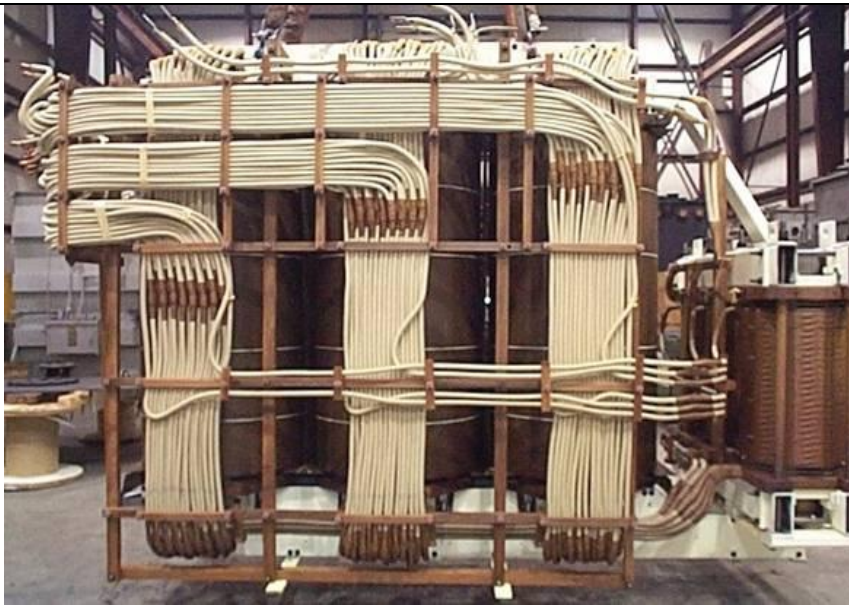
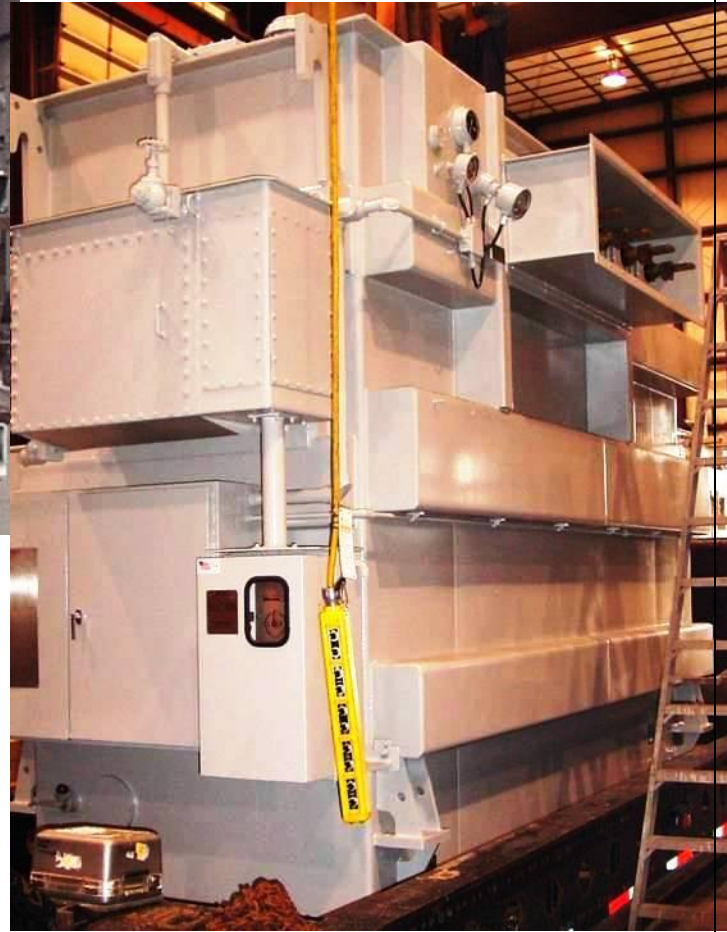
**Transformer tested as good and core & coils were able to be reused.**  
**Transformer tank was sandblasted and painted.**  
**New bushings, gauges, fans, wiring and conduit.**  
**New LTC and controls.**  
**Back in service!**
