# Jordan Transformer Mobile Project

7.5 MVA FOA 69000 x 34500 – 7200/12470Y/7200 x 2400/4160Y/2400 GE

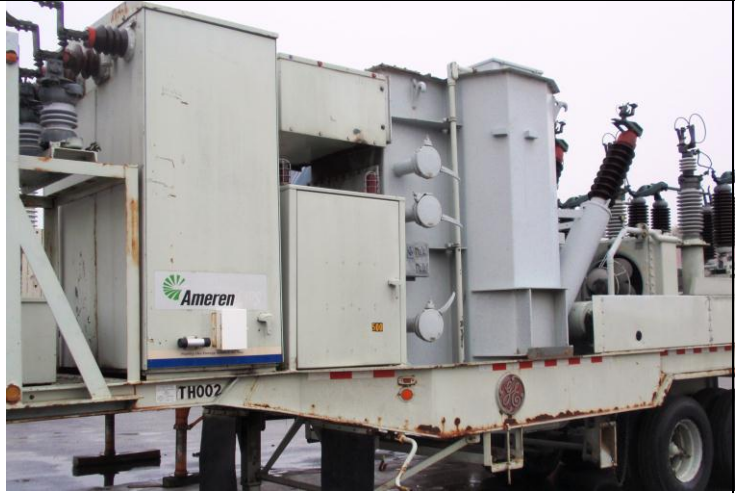
DGAs showed 128 PPM Acetylene

The oil pump motor was failing & generating the acetylene. The pump was remanufactured. The core & coils were dried out and reused. Entire mobile was reconditioned and load tested to confirm the diagnosis.

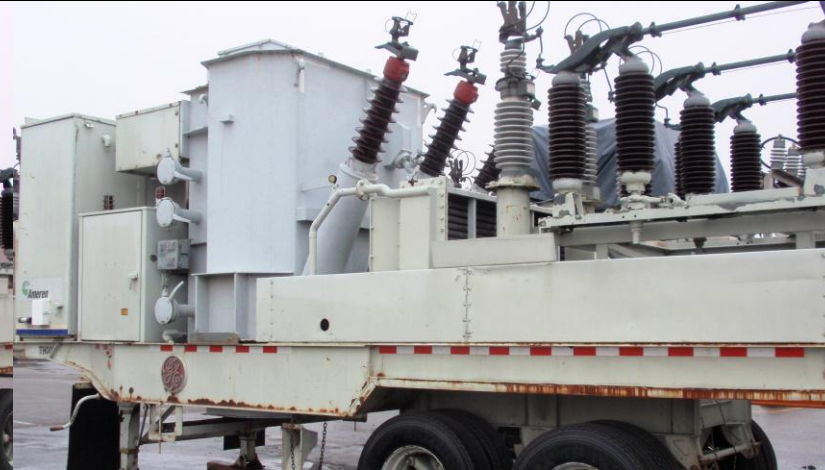
Transformer was gassing 1 PPM acetylene each day in service

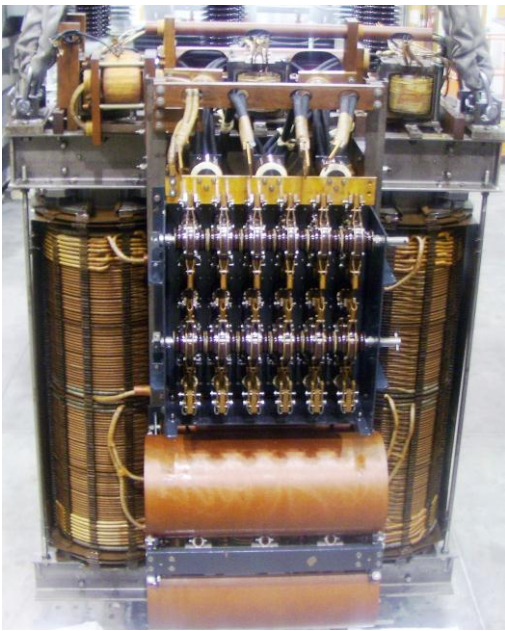
Core & Coils tested as "good"
